Manhole Inspection Summary

Manhole # S13CC2025MH

Location Address: **5727 RIDGEDALE RD**

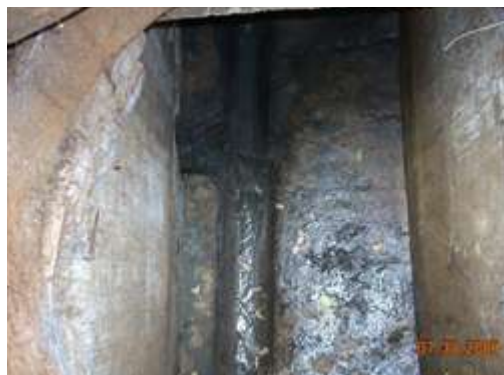
Top View

Evidence of surcharge - Bench debris.

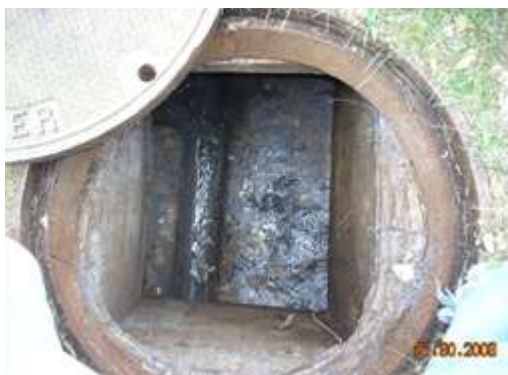
Top View

Evidence of surcharge - Bench debris.

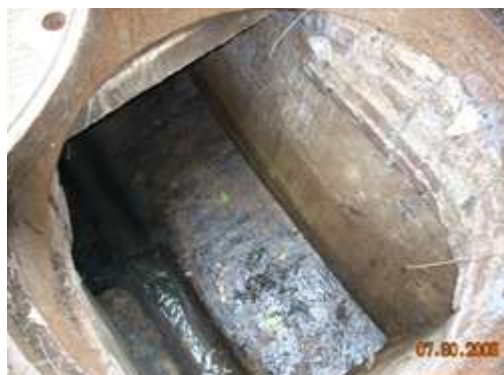
Defect

Frame leaks. Adjustment deterioration, root intrusion and infiltration. Corbel and Barrel infiltration.

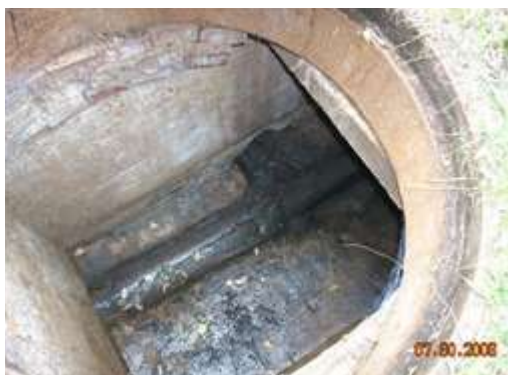
Defect

Frame leaks. Adjustment deterioration, root intrusion and infiltration. Corbel and Barrel infiltration - other side.

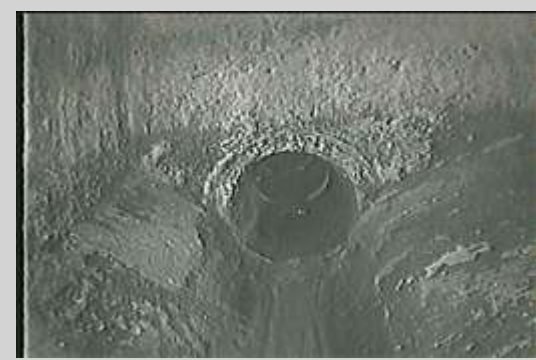
8 in. Circular Gravity Sewer Pipe Out @ 12 O'Clock

Infiltration: **Evidence** Pipe Seal Cond: **Unknown**

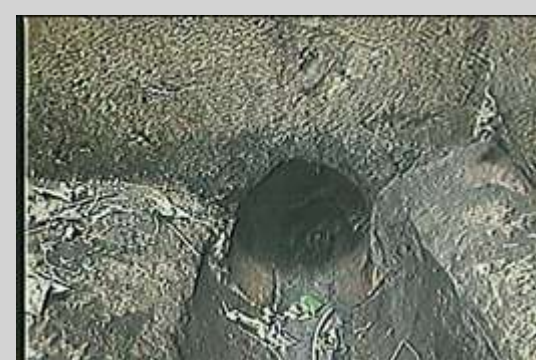
6 in. Circular Gravity Sewer Pipe In @ 6 O'Clock

Infiltration: **Evidence** Pipe Seal Cond: **Unknown**
